# Manhole Inspection Summary

Manhole # S65O\_\_013MH

**Location** Address: **1316 Bonsal St.**

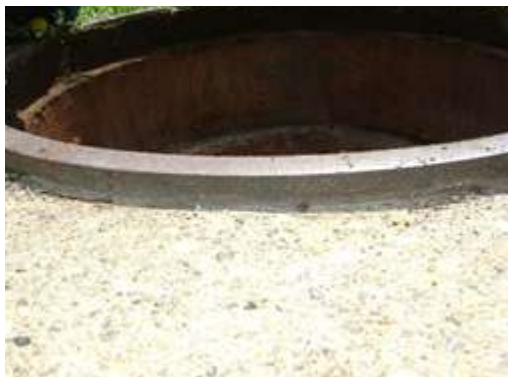
Defect 2

Above Grade

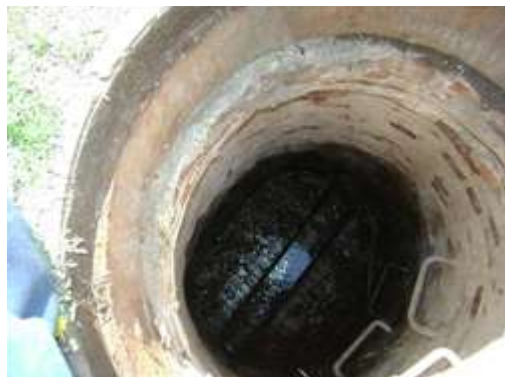
Defect 1

Offset

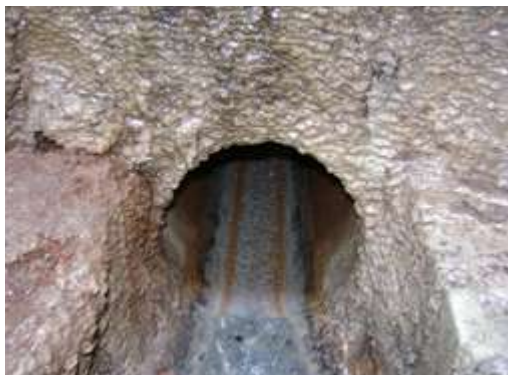
Defect 6

Deposits encrusted

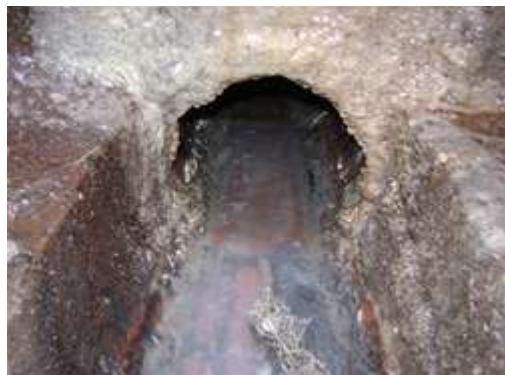
Defect 3

Encrustation

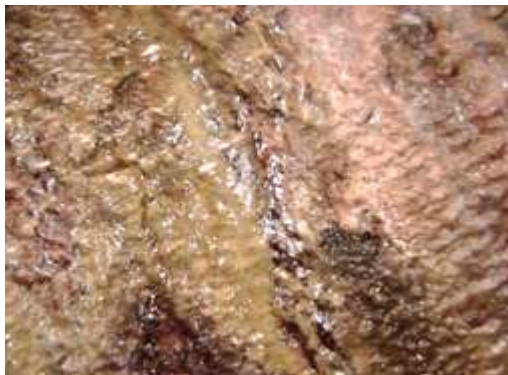
Defect 4

Infiltration: ☐ None ☒ **Joint** ☐ Cracks ☒ **Mortar** ☐ Roots ☐ Wall

Infiltration

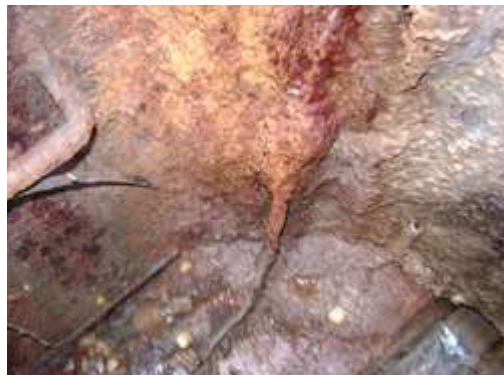
Defect 5

Condition: ☐ Sound ☐ Cracked ☒ **Root Intrusion** ☐ Loose Brick ☐ Deteriorated

Root Intrusion

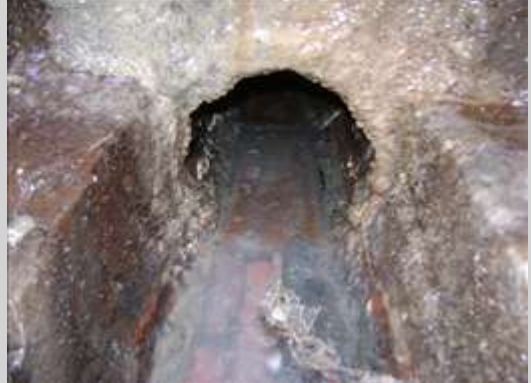
12 O'Clock Outflow

8 in. Circular Gravity Sewer  
Pipe Out @ 12 O'Clock

Pipe Height: **8.4** (in.) Rod and Bar (Angled)  
Pipe Material: **Clay** ☐ Pipe Lined  
Invert Depth: **10.08** (ft.) Flow Characteristics: **Slow**  
Deposits: ☐ None ☐ Mud ☐ Sludge ☒ **Debris** ☐ **Grease**  
Silt Depth: **0.25** (in.) Deposits Extent: **Light**  
Infiltration: **None** Pipe Seal Cond: **Sound**

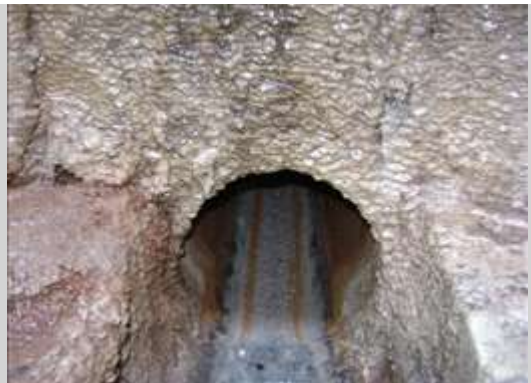
6 O'Clock Inflow

8 in. Circular Gravity Sewer  
Pipe In @ 6 O'Clock

Pipe Height: **8.4** (in.) Rod and Bar (Angled)  
Pipe Material: **Clay** ☐ Pipe Lined  
Invert Depth: **10.04** (ft.) Flow Characteristics: **Slow**  
Deposits: ☐ None ☐ Mud ☐ Sludge ☐ Debris ☒ **Grease**  
Silt Depth: **0.125** (in.) Deposits Extent: **Light**  
Infiltration: **None** Pipe Seal Cond: **Sound**
